Transforming Black Liquor to Biofuel

D1.5 - Report on corrosion resistant alloys and recommendations (M30)

Lead Beneficiary: SINTEF Industry

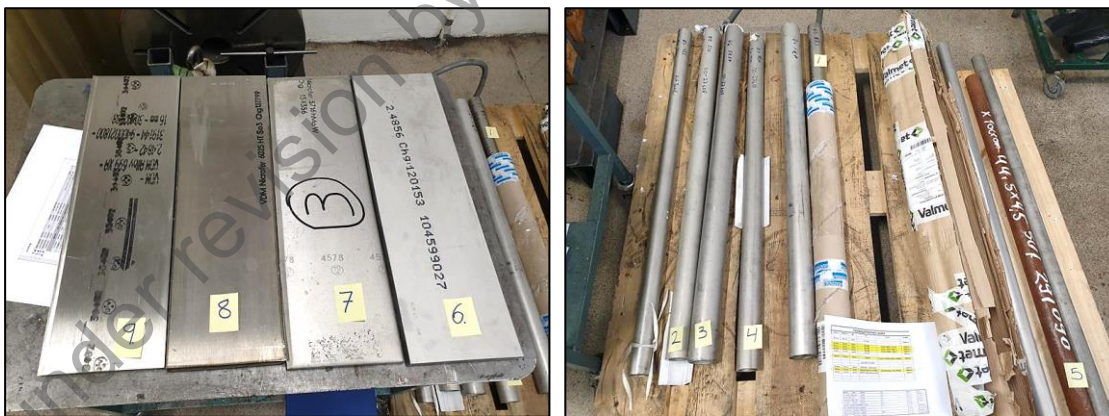
Figure 1. Upper: The short list of 9 potential material candidates to be tested with alloy composition. Lower: Photos of the received test materials.

A detailed presentation of the selected 9 material candidates for the corrosion testing are presented in Figure 1.

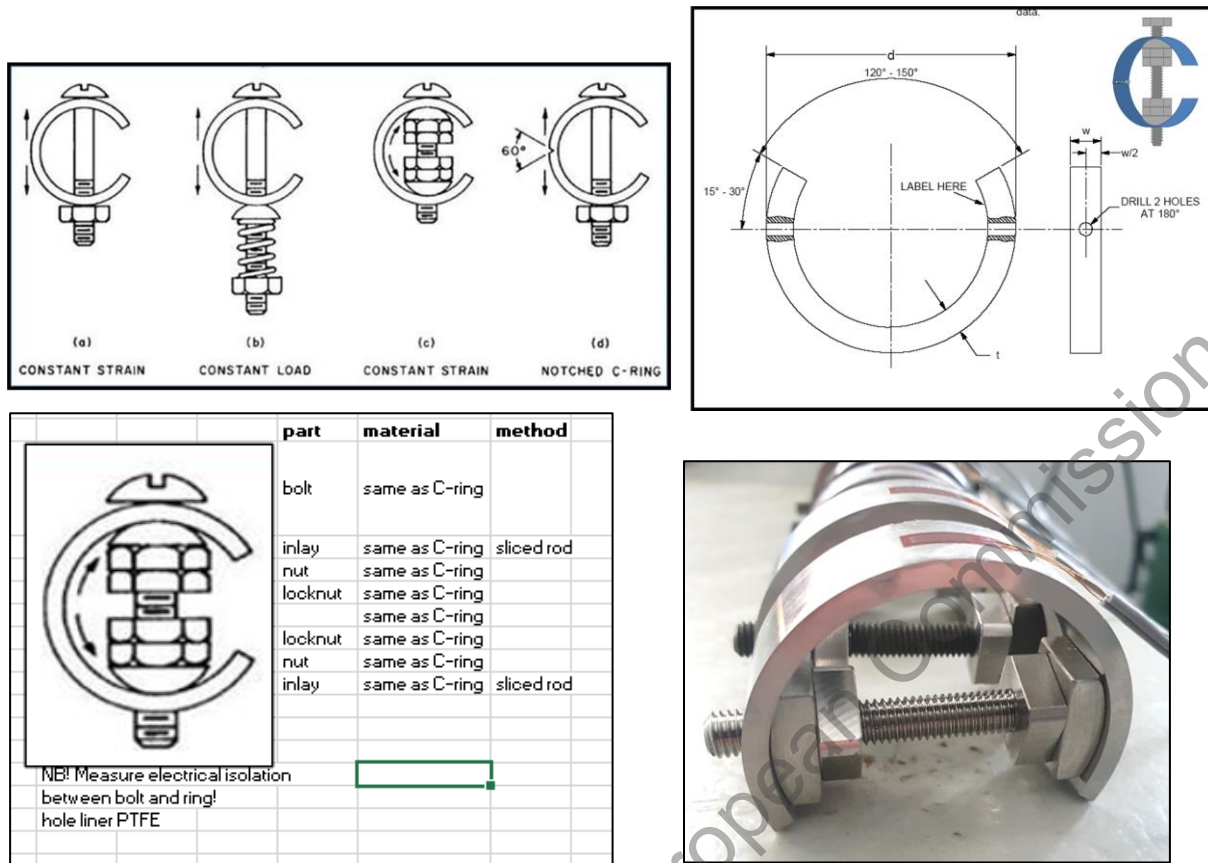
Figure 2. Schematic drawing of C-ring sample according to NACE TM0177 method C.

The test specimens have the form of C-rings to simulate the hoop-stress from the high inside pressure in the real process. Hoop stress is the stress that occurs along the pipe's circumference when pressure is applied. Hoop stress acts perpendicular to the axial direction. Hoop stresses are tensile and generated to resist the bursting effect that results from the application of pressure. Stress-strain curves were generated by tensile testing for the different materials at the desired test temperature to be able to stress (pre-load/deflect) the C-rings with bolts and nuts to achieve the desired yield strength on the inside of the rings. The C-ring test is NACE TM0177 method C /4/, and there is also guidance given in EFC 16 /5/ and EFC 17 /6/, see Figure 2.

The C-ring test is effectively a bend/deflection test, suitable for relatively small tubulars. If the ring is compressed, a tensile stress is generated on the outside. However, as pipes usually carry the environment of concern on the inside, the ring must be expanded, producing stress in the hoop direction by opening the C-ring with the centered bolt as shown in Figure 2.

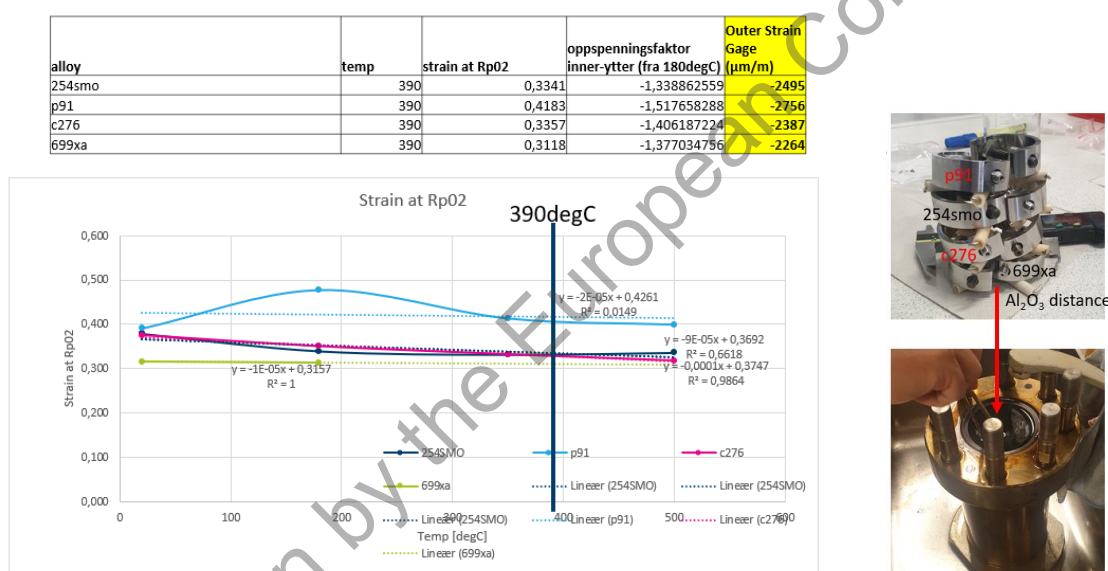
Figure 5. Left: Outside compression vs. inside stress at yield at 390°C (based on in-house data and some extrapolation). Right: C-rings insertion into the HTL-reactor.

As for the screening testing reported above, it was machined rods and nuts from the same material quality as the C-rings to avoid galvanic corrosion. Thereafter, the C-rings were pre-loaded with strain-gauges to achieve the desired inside yield strength at 390°C.

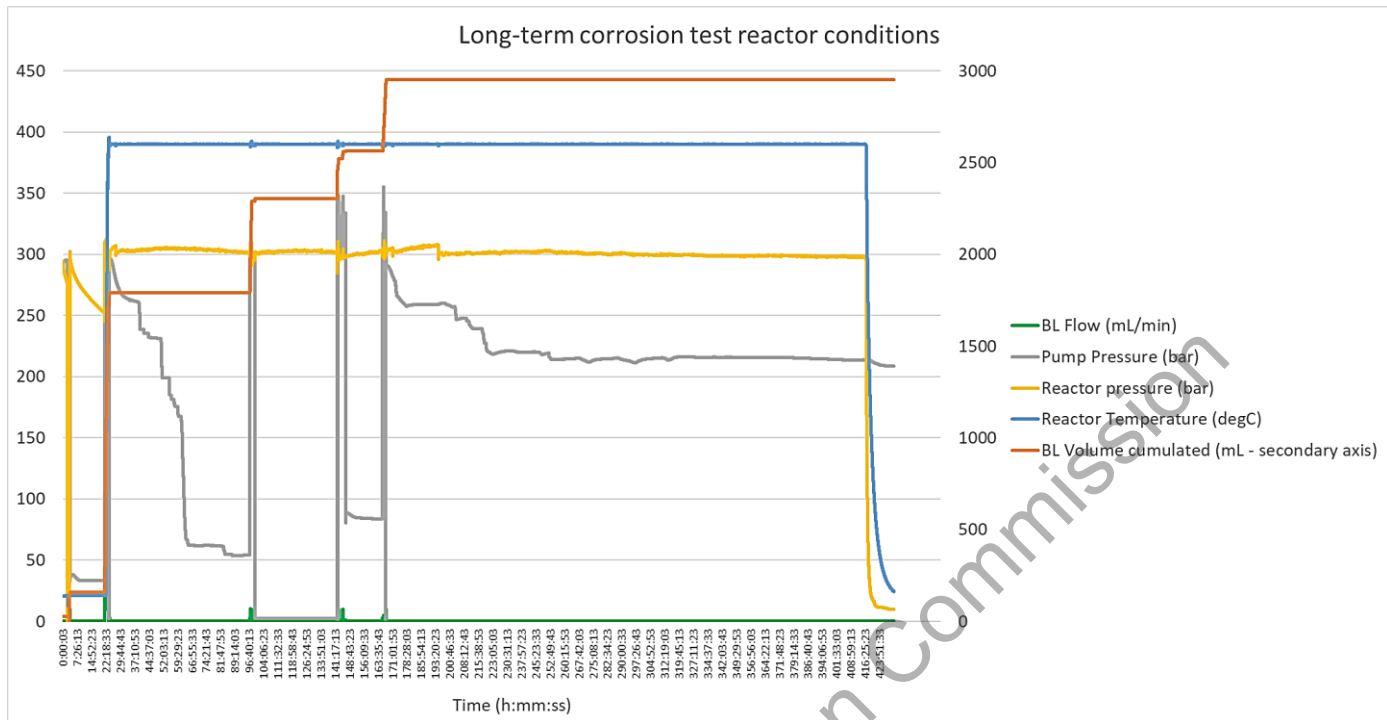
Figure 7. Reactor conditions during long-term corrosion tests. BL: simulated water based black liquor

The long-term corrosion test was performed in a semi-continuous mode, by continuously operating during daytime at the first days and leaving the reactor at batch conditions during night-time. Due to clogging, the reactor was operated only in batch mode after the first week. Figure 7 shows the reactor conditions during the test, indicating the correct pressure and temperature conditions ($390\text{ }^\circ\text{C}$; 300 bar) during the entire test period. The figure indicates also that there were disturbances due to clogging also during the first week but at that time, continuous operation was still possible with increased pump pressure and reduced flow.

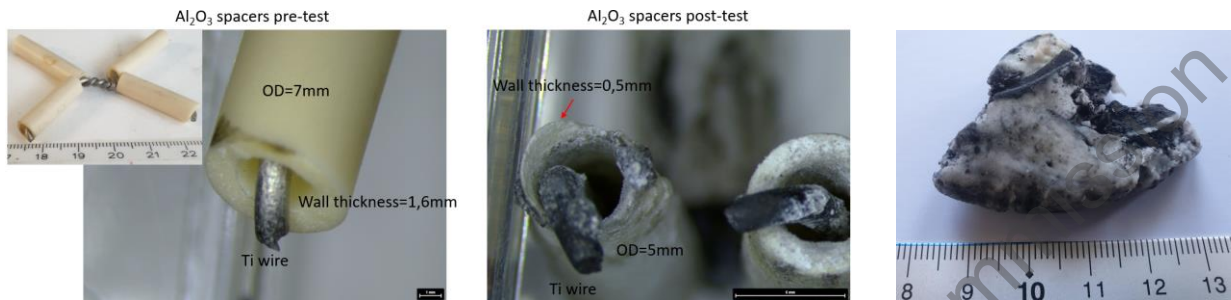
Figure 8. Left: Images of alumina spacers on Ti-wire suffering from dissolution in SC conditions. Right: salt crust found at the bottom of the reactor after the test.

Salt deposits were clogging the reactor and were found at the inlet to the reactor, in the reactor (both on the sample spacers and at the reactor bottom) and at the outlet as well. The clogging was seen to consist of salt crusts, see Figure 8.

Analysing the salt crusts with ICPMS showed the presence of Na (from the BL), Cr, Mn, Fe, Ni, Mo, W and Al from the corroded samples and the alumina spacers, and N from the HNO₃ in which the salt crusts were dissolved.

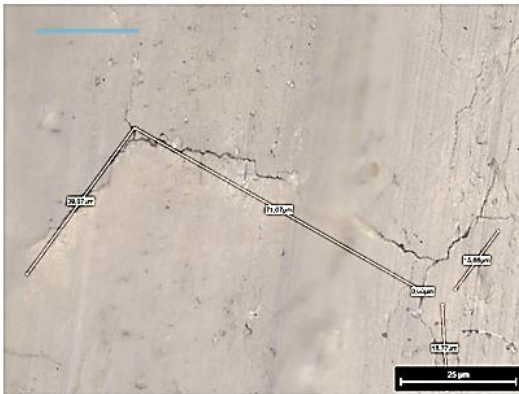
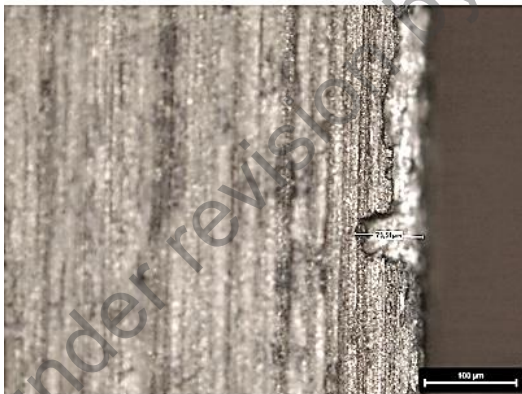
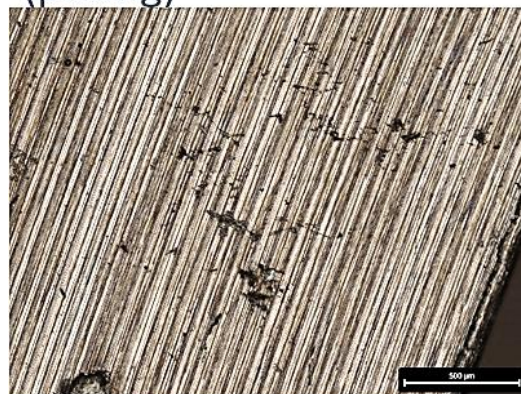
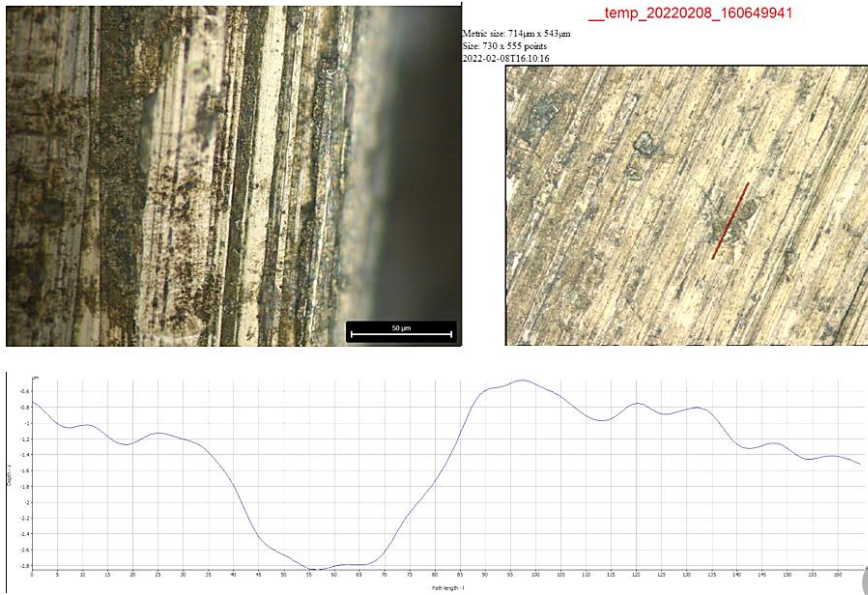
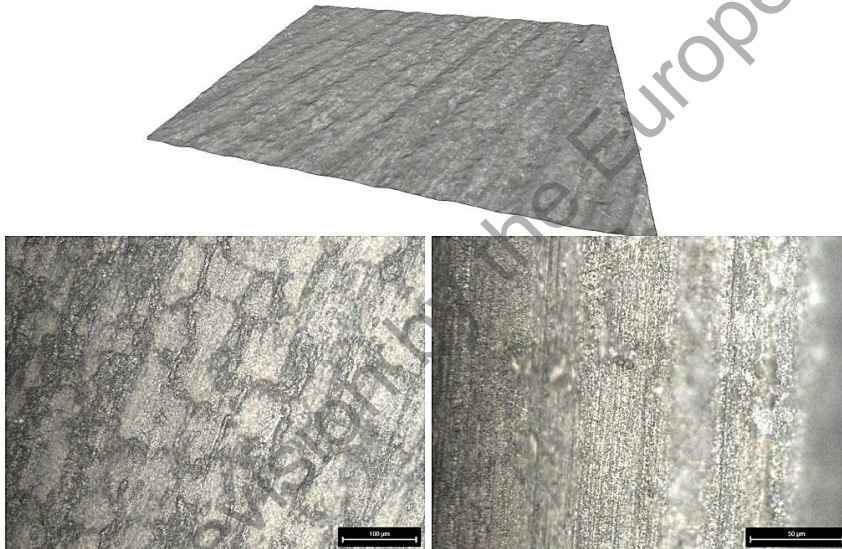
Sample 1, Ti grade 2
(pitting, cracking)

Sample 2, AISI 316
(pitting)

Sample 3, SAF
2507, SDSS
(pitting)

Inconel 625 (some pitting)

602 CA (some pitting and inter-crystalline corrosion)

Figure 9. Optical microscopy images obtained from post-screening test examination of the inner, stressed edge of the C-rings as indicated by the red arrow (upper right on previous page). Candidates with insufficient corrosion resistance:

After the screening test, the post-test examination revealed an unacceptable corrosion performance of Ti grade 2, AISI316, SAF2507, Inconel 625 and 602 CA, see Figure 9. These alloys were hence not included in the final exposure to the supercritical conditions in the SINTEF ER reactor.

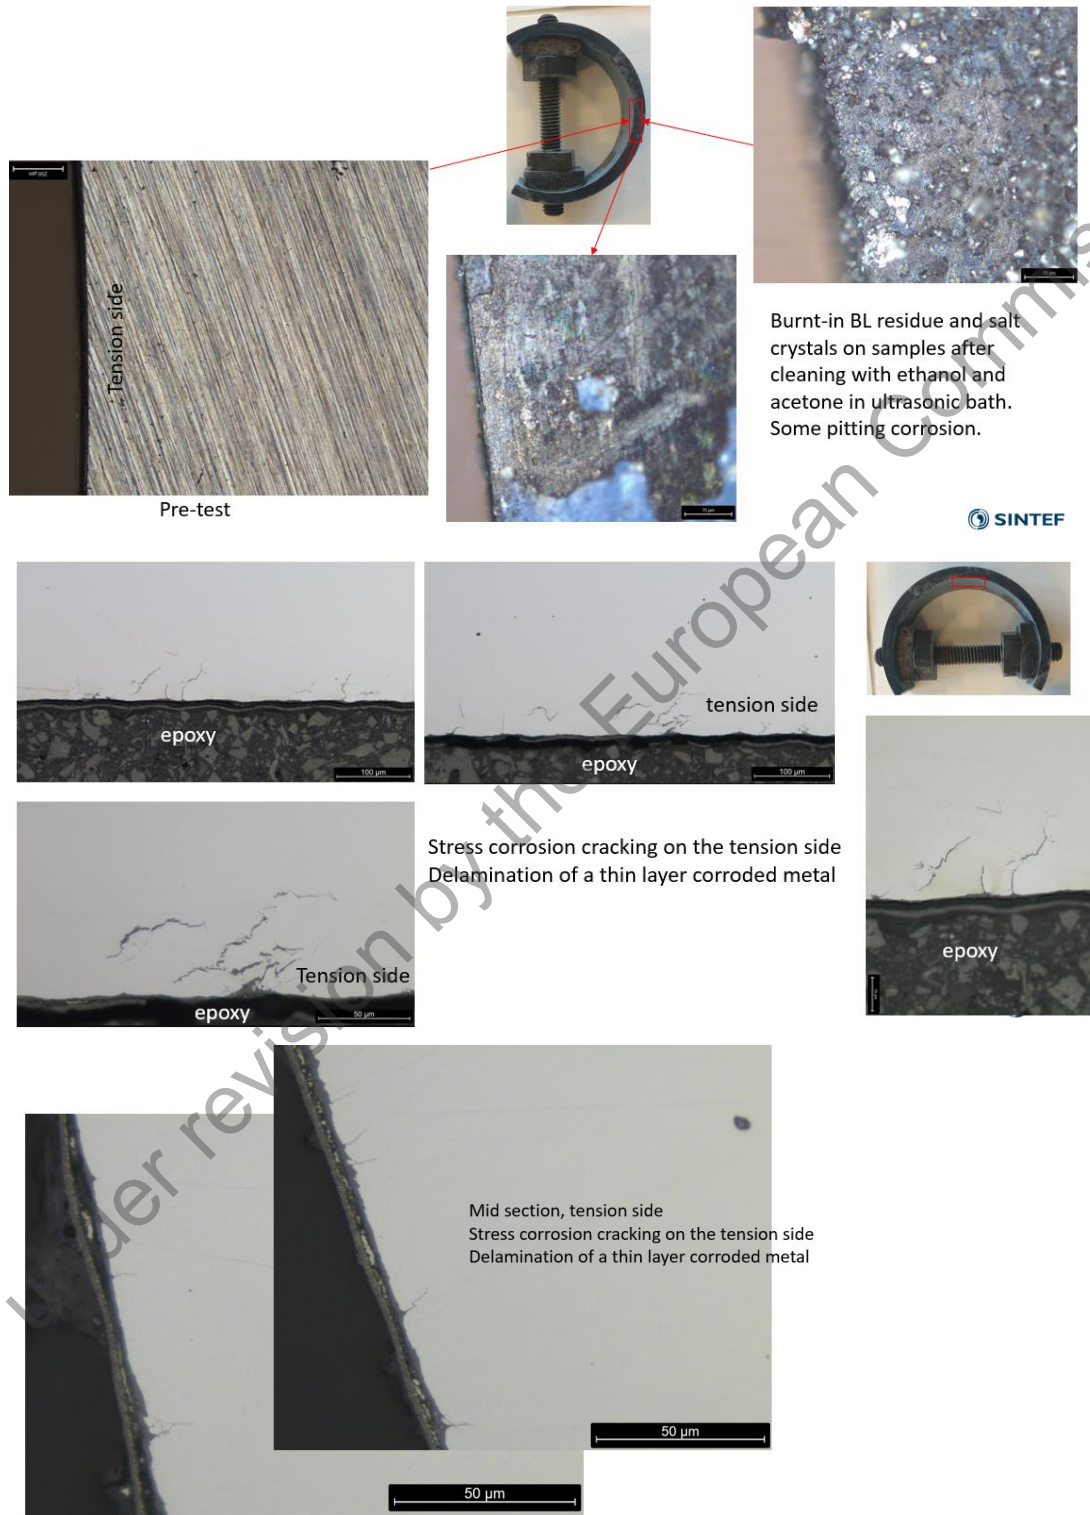
Figure 10. Post-test analysis of 254SMO by optical imaging of tension side

The optical microscopy images of 254SMO, SAF 2507(SDSS) as tested is seen in revealed burnt-in BL residue and salt crystals. Some cracking of the tension side indicating stress corrosion cracking (SCC) was also seen.

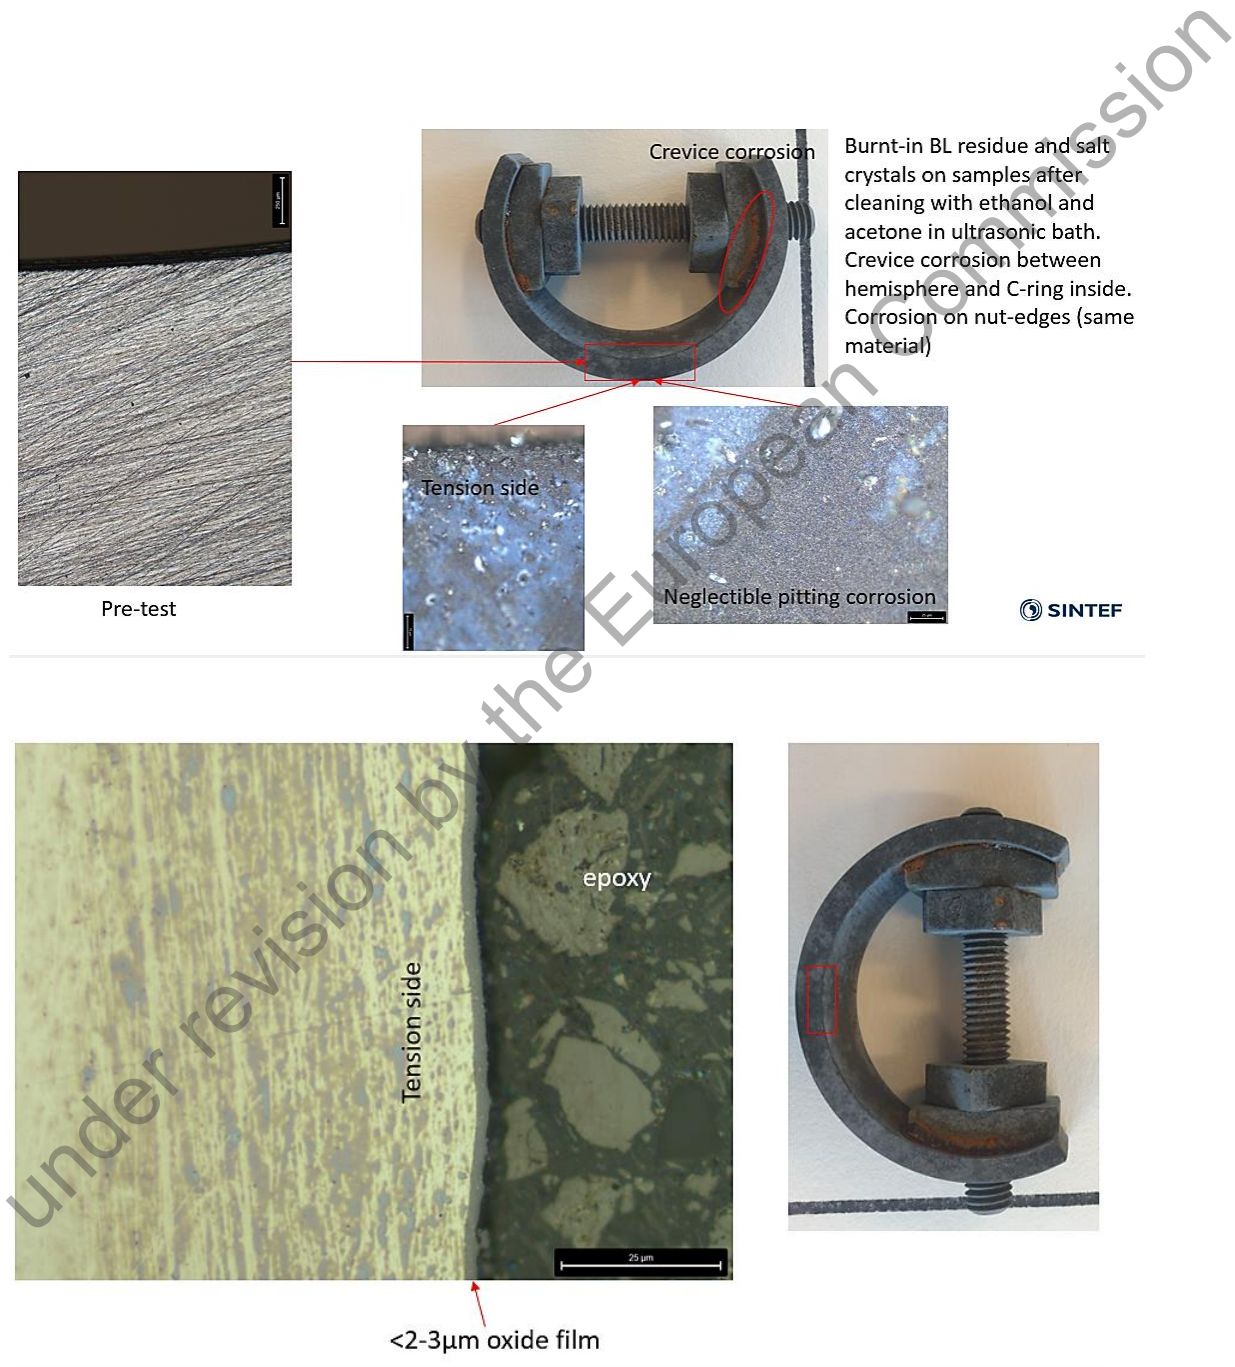
Figure 12. Post-test analysis of P91 performed with optical microscopy of sections.

For the P91 samples, some crevice- and edge corrosion were seen on the nuts and hemispheres (also made of P91) used for tensioning of the C-rings. Also, residues from the BL and salt crusts were seen. However, very little signs of corrosion were evident on the stressed inside of the P91 C-rings after the 18 days of exposure in SC environment in the SINTEF-ER reactor, see Figure 12. Some minor pitting corrosion was seen in the mid-section of the C-ring, see Figure 13.

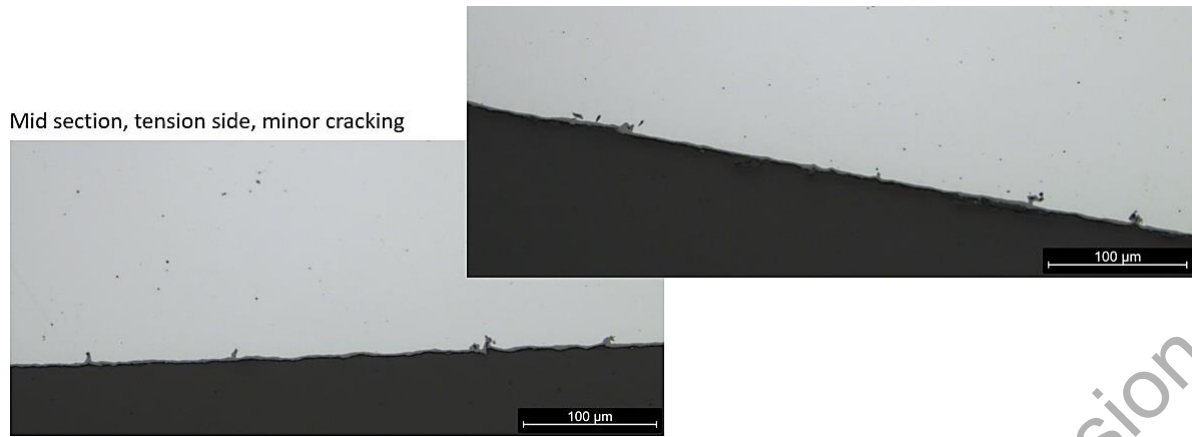
Figure 13. Optical microscopy images of P91 mid-section after exposure to SC conditions revealing only minor pitting.

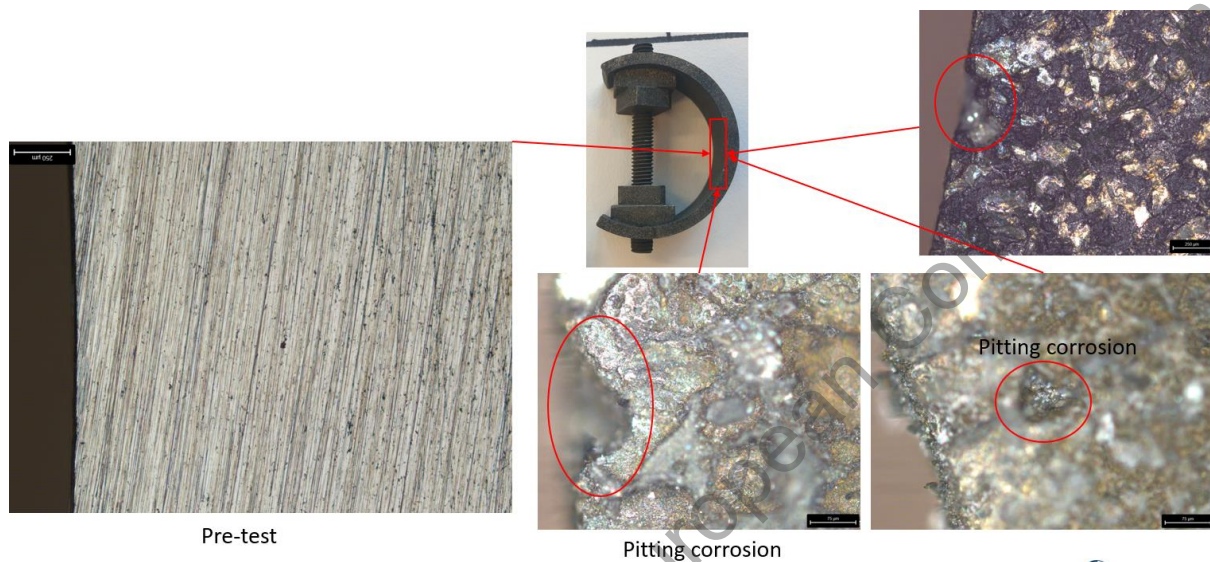
Figure 15. Optical microscopy images of C276, as tested. Burnt-in BL residue and salt crystals on samples are seen after cleaning with ethanol and acetone in ultrasonic bath.

For the austenitic Ni-base Hastelloy C-276 samples, BL residues and salt crystals on the exposed surface were found. Pitting corrosion was evident on the stressed inner edge of the C-rings and on the surface, see Figure 15.

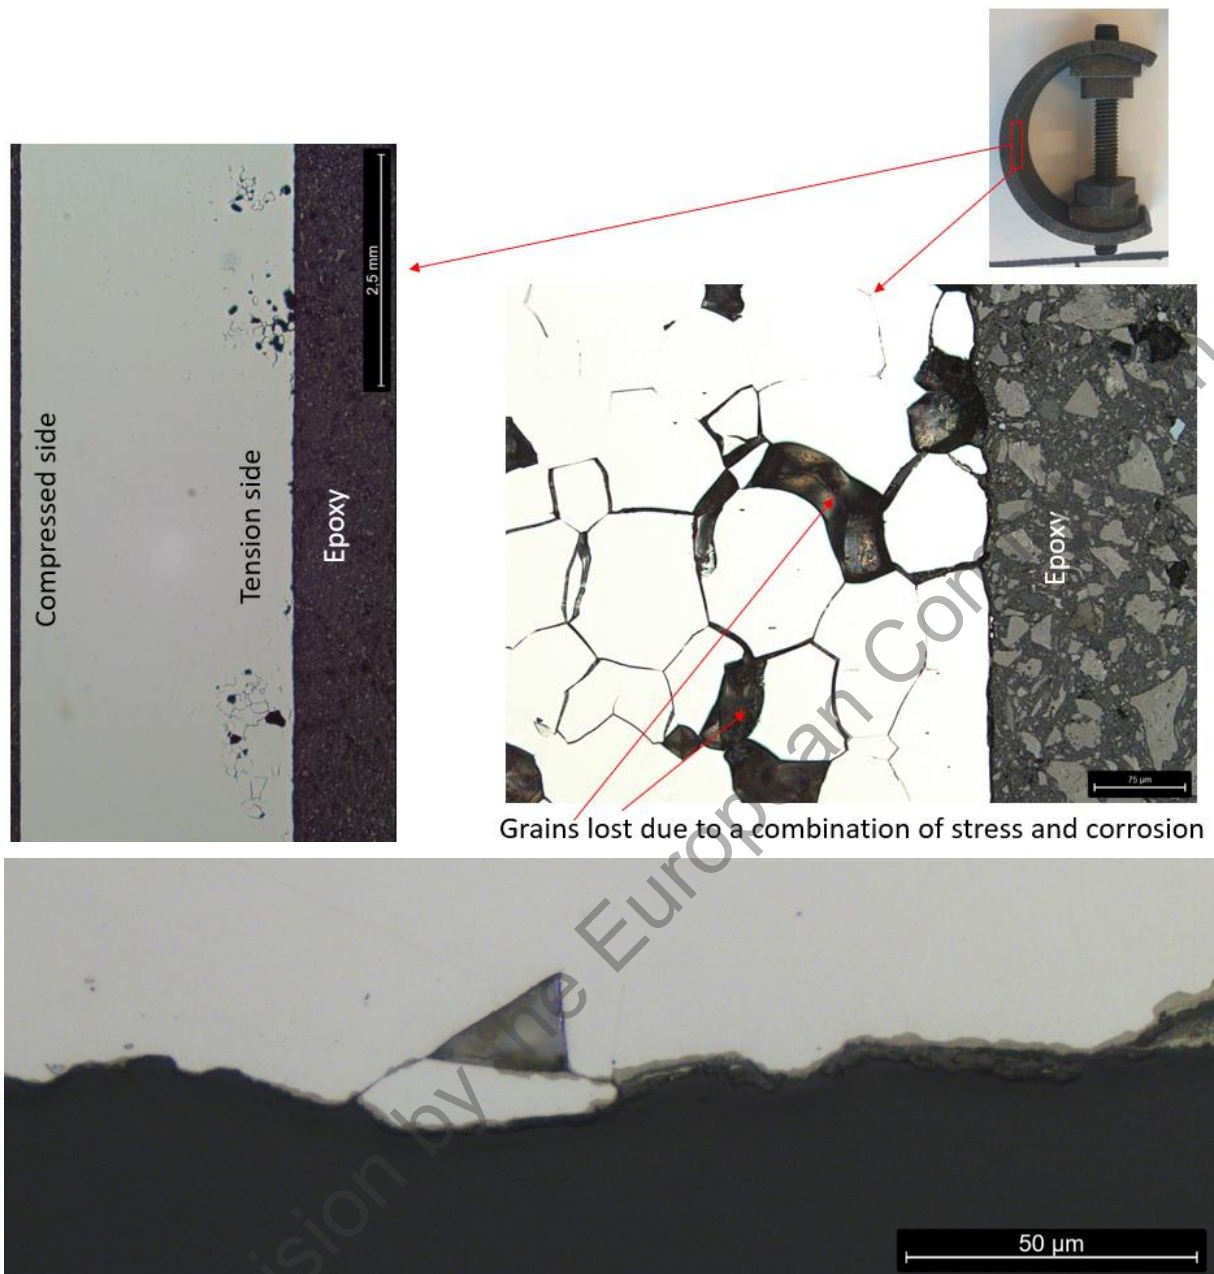
Figure 16. Optical microscopy images of as tested C-276 C-rings. The loss of some grains is seen because of the combination of applied stress and corrosion.

A more detailed analysis showed that also intercrystalline corrosion had taken place with the loss of occasional grains because of the applied stress in combination with corrosion, see Figure 16.

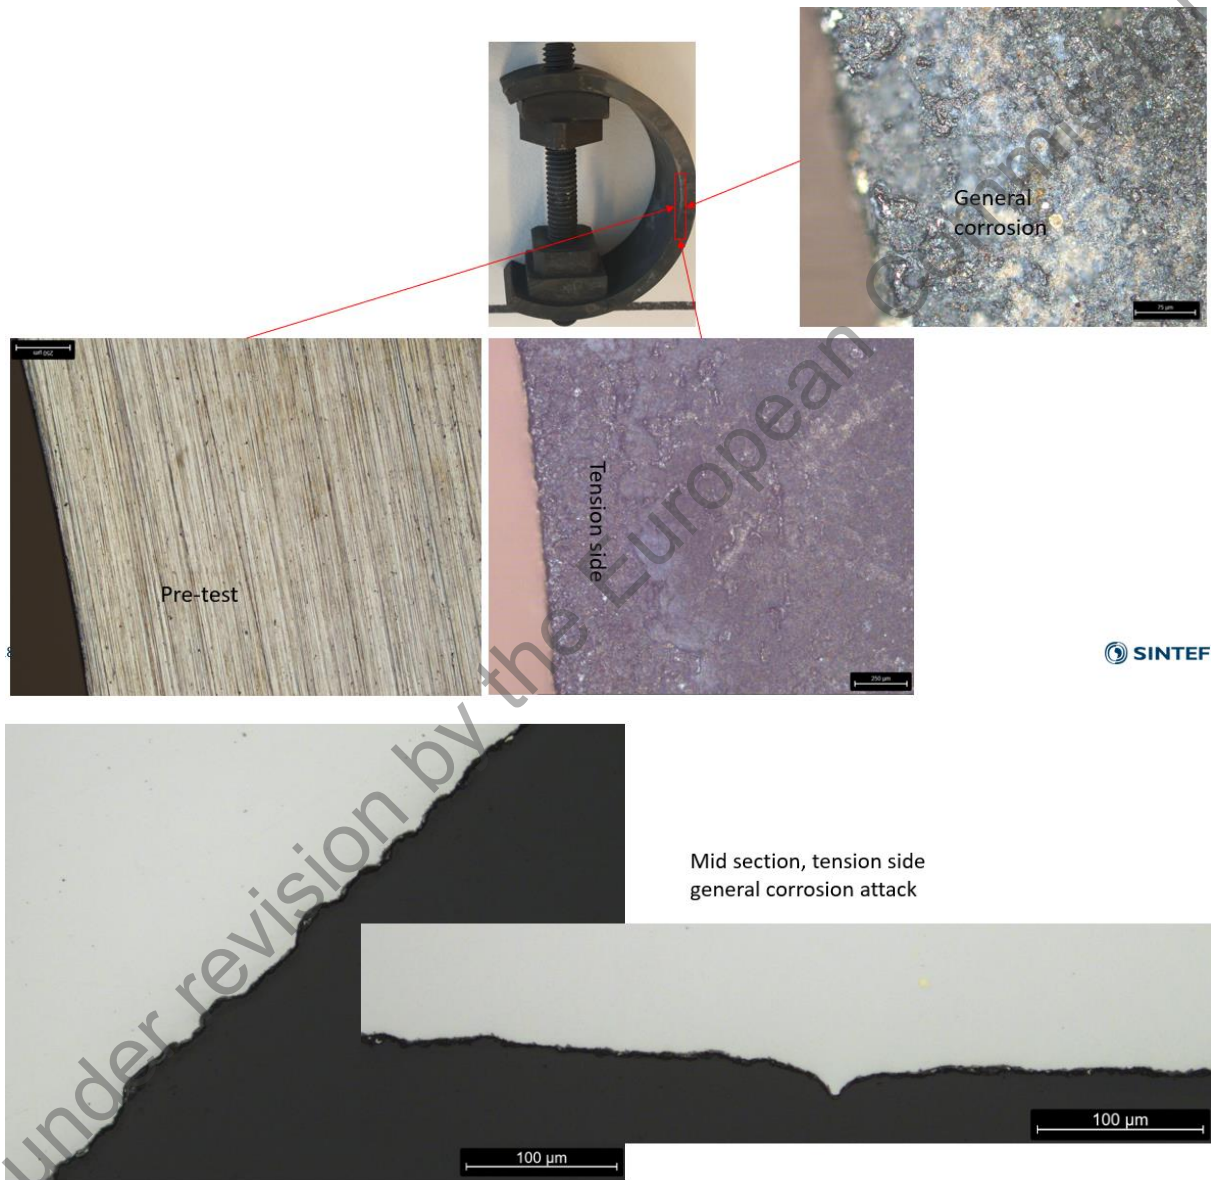
Figure 18. Optical microscopy images of sections of the 699XA NiCr alloy with Al as tested revealing general corrosion.

The as-tested 699XA NiCr alloy is just like the other 3 candidates seen to have BL residues left on the surface after testing in the HTL-reactor at SC conditions. Also here, salt crystals are present. A general corrosion attack is evident on the edge of the tension side of the exposed C-rings, see Figure 18. Stress corrosion cracking and lost grains are seen on the tension side of the 699XA section after exposure to SC conditions.

Also, on the mid-section of the C-ring, general corrosion was seen.

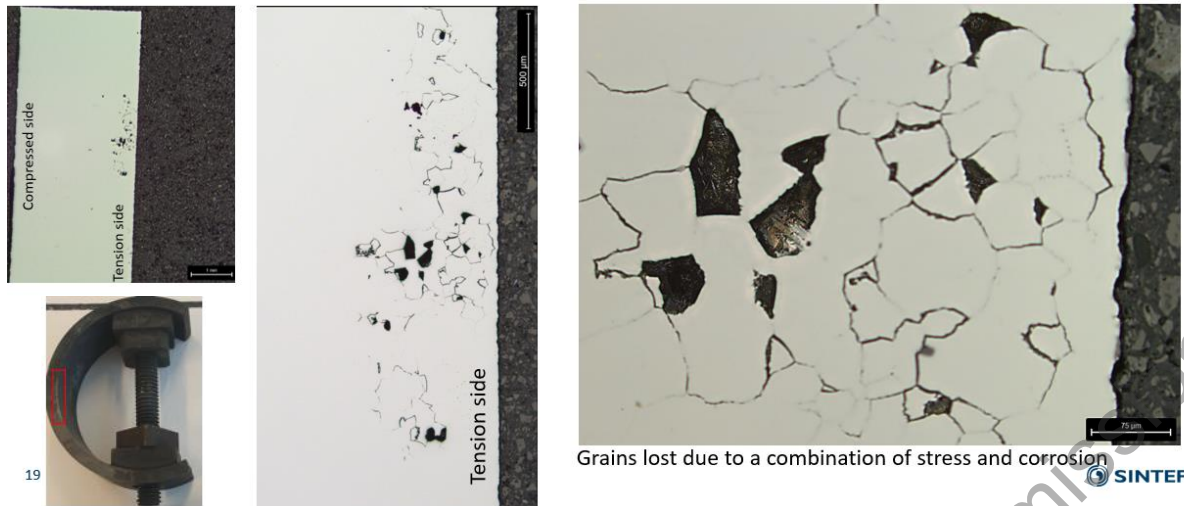
Figure 19. SCC and lost grains on the tension side of the 699XA imaged by optical microscopy.
